MAIDSTONE BOROUGH COUNCIL

Mote Park Lake

**Assessment of whether the risk of failure of the dam
during flood events is
“As low as reasonably practicable” (ALARP)**

April 2017

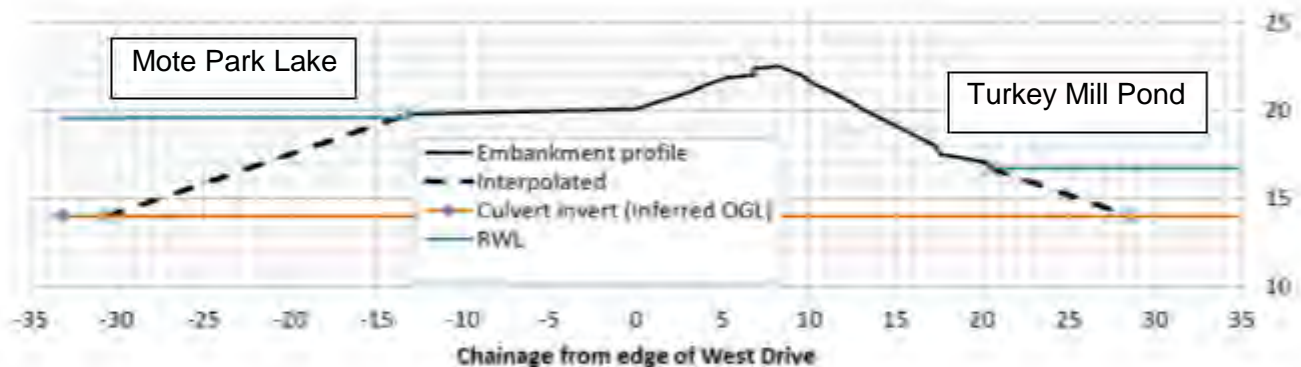
Figure 3.1: Embankment cross section

Although overall height to lowest foundation is around 10m, water level from Turkey Mill Pond is impounded against the downstream face, such that the retained height of water is only around 4m, with 2m freeboard.

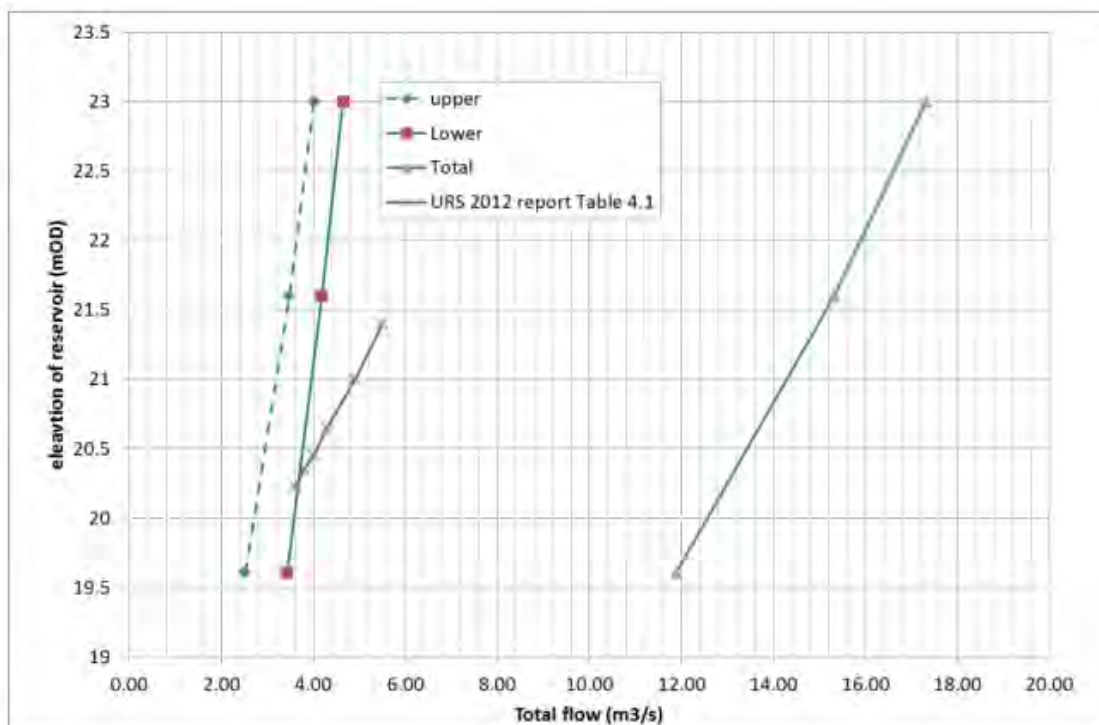
Figure 3.4: Estimated capacity of sluice gates

It is also understood that gates at Turkey Mill Pond are used to create a “waterfall” used as a backdrop for weddings.

It is noted that Category A dams should have means of lowering the dam in an emergency, such that it is **recommended that at least one gate is kept in good working order.**

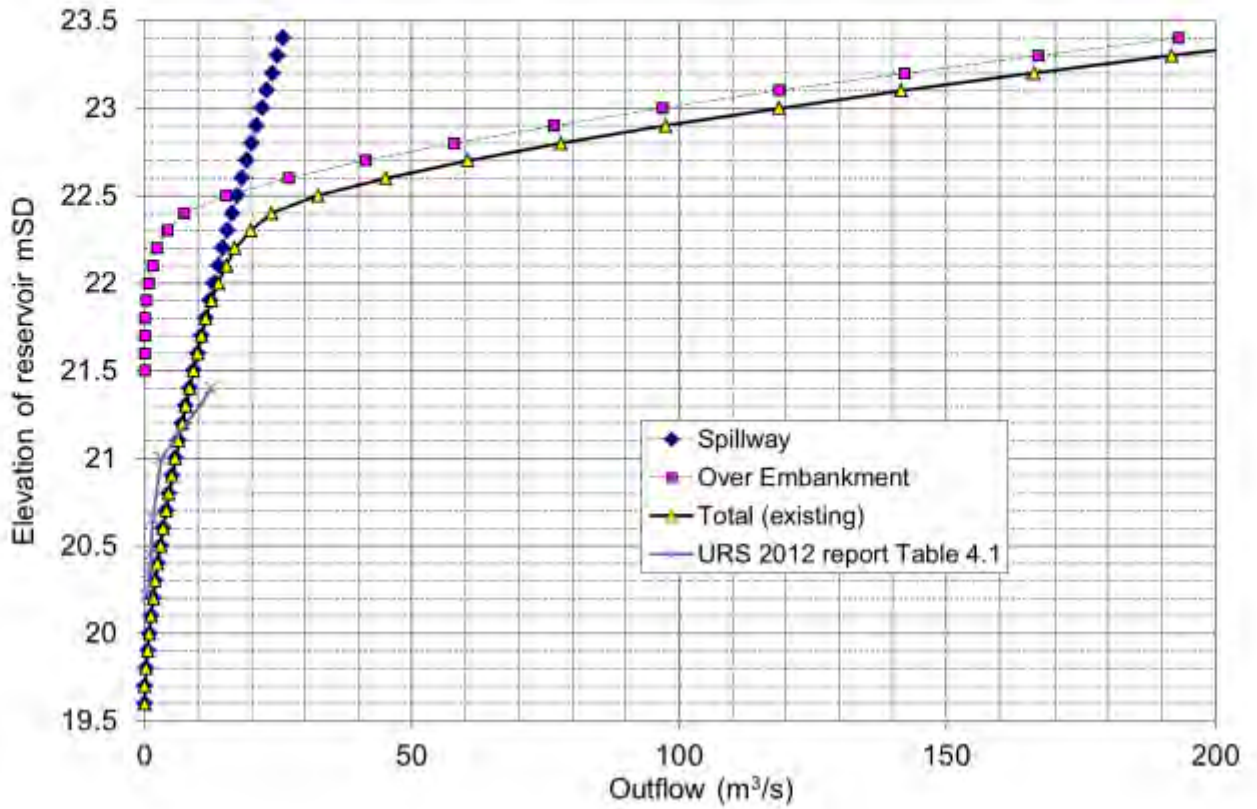
Figure 3.6: Existing spillway capacity

The current capacity of the spillway (with the sluice gates closed) as the dam starts to overtop is around 11m³/s which represents a flood with an annual chance of 1 in 100. This is well short of the PMF value of 336m³/s required as a safety check flood for Category A dams (and also a 1 in 10,000 chance per year flood of 119 m³/s which would be the safety check flood for Category B dams). If all four sluice gates were operational and fully open the capacity is doubled to 22m³/s, reducing the imminent failure capacity to around a 1 in 200 chance per year and this was presumably the historical capacity.

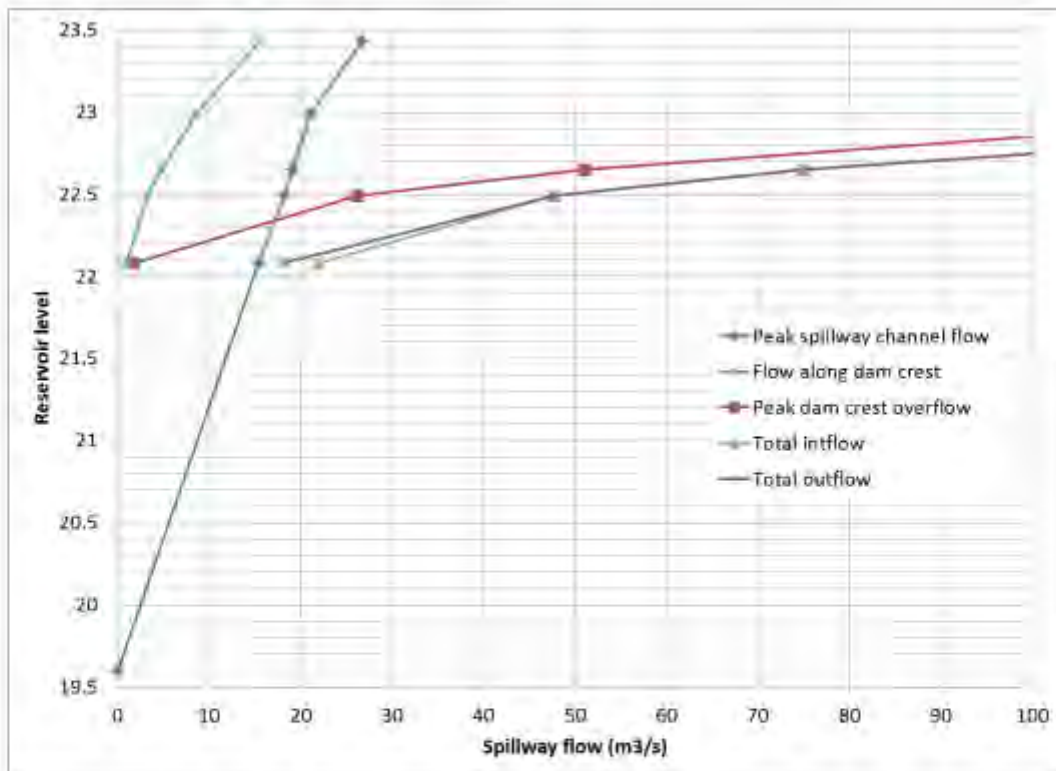
Figure 4.1: Estimated flow over the spillway and dam

The overtopping flow that is likely to just cause failure is termed the Dam Critical Flood in the Interim Guide for Quantitative Risk Assessment for UK Reservoirs (2004). The amount of overtopping that would trigger damage sufficient to release the reservoir will depend on the velocity needed to cut through the grass cover and erode the material below, and the stability of the downstream face with elevated pore pressures due to infiltration.

Floods and Reservoir Safety 4th Ed. (ICE 2015) provides a methodology to estimate the maximum velocity on grass for no damage. For a 1V:2H slope with poor grass cover and storm duration of say 15 hours the limiting (no damage) velocity is 1.4 m/s from Figure 12 of Floods and Reservoir Safety (reproduced in Appendix B), which is reached at an overtopping depth of 0.04m. Assuming the head over the crest necessary to cause failure is 0.14m (see Table 6.3) this corresponds to a velocity of 2.8 m/s with a unit discharge of 0.06m³/s/m. The assessed total flow at failure, and associated annual chance of failure are given in Table 6-5, and amount to 1 in 100 chance per year (with no release from the gates).

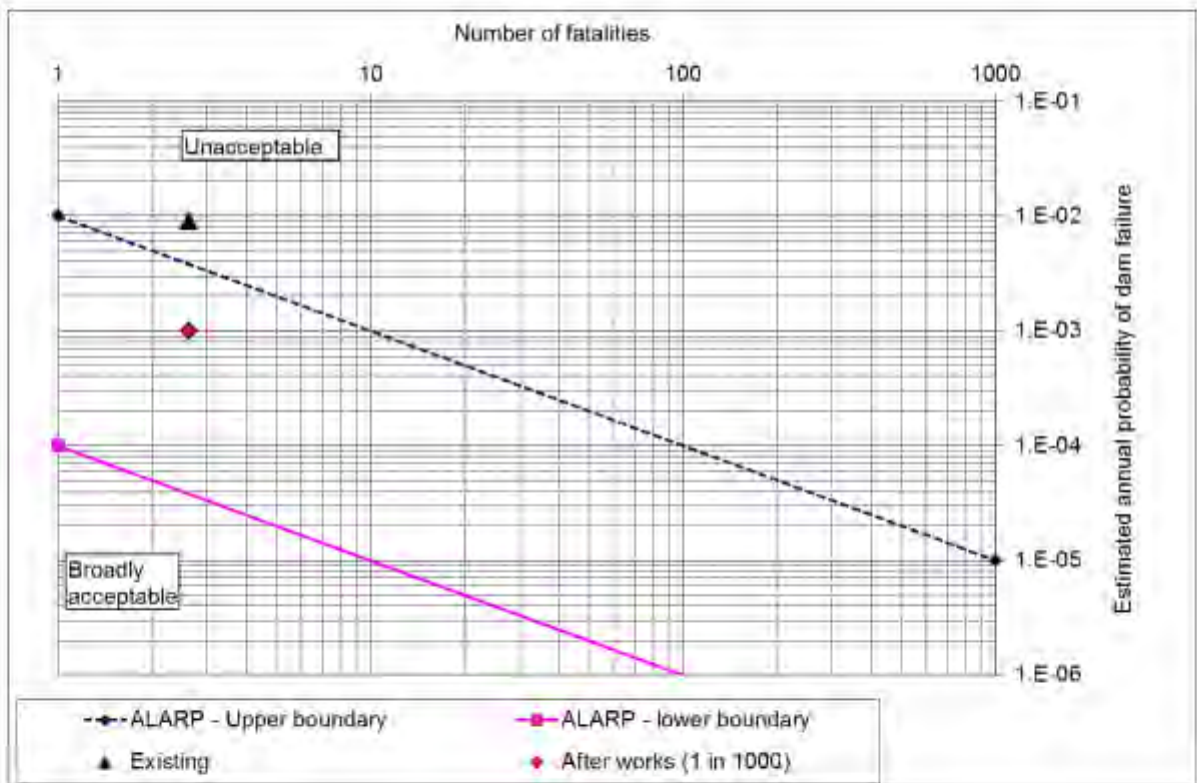
Figure 5.4: FN chart showing tolerability of risk of dam failure

The risk of loss of life of those living in the house nearest the dam due to the dam failing in floods, is the product of the probability of failure (1 in 110 annual chance per year) and the probability of death given that the dam had failed (0.7%), namely 1 in 16,000 per year chance per year. This is between 1 in 10,000 and 1 in one million chance per year and is therefore in the ALARP zone (using limits recommended by HSE as tolerable for risk to the public from hazardous installations (HSE, 2001).

The current risk is shown on the figure below as in the ALARP zone, where the risk should be reduced as low as reasonably practicable (see Appendix A). If the probability of failure could be reduced to 1 in 10,000 per year, the dam would then be in the broadly acceptable zone.

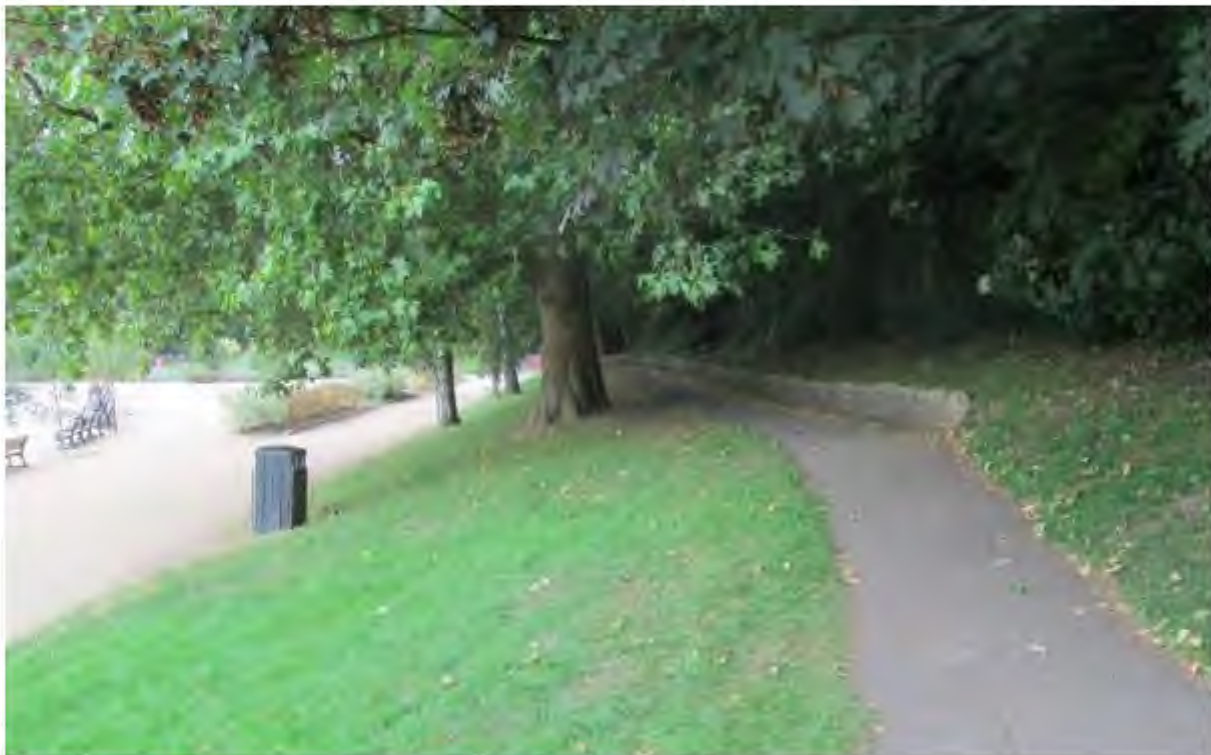
Photograph 9: East end of high level path; showing end of crest wall

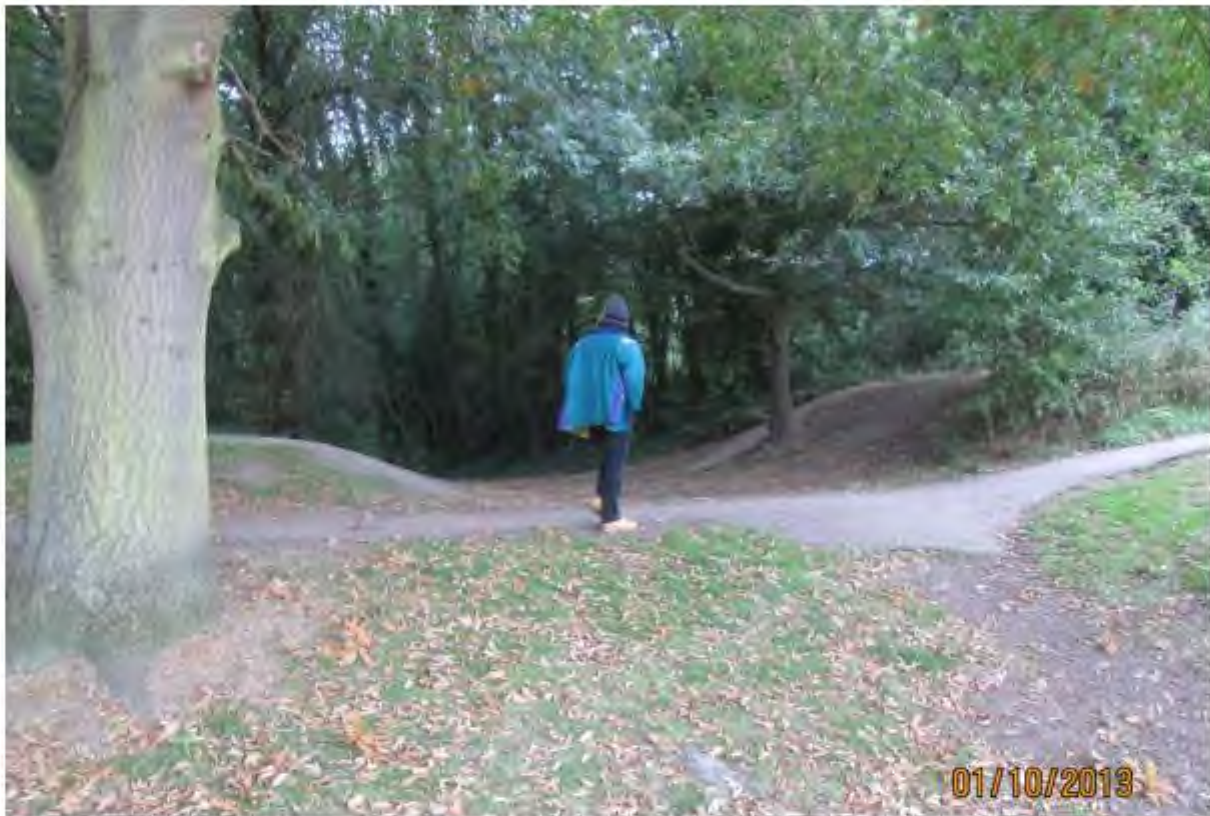
Photograph 10: Low spot providing access to Mote Park boat club storage container

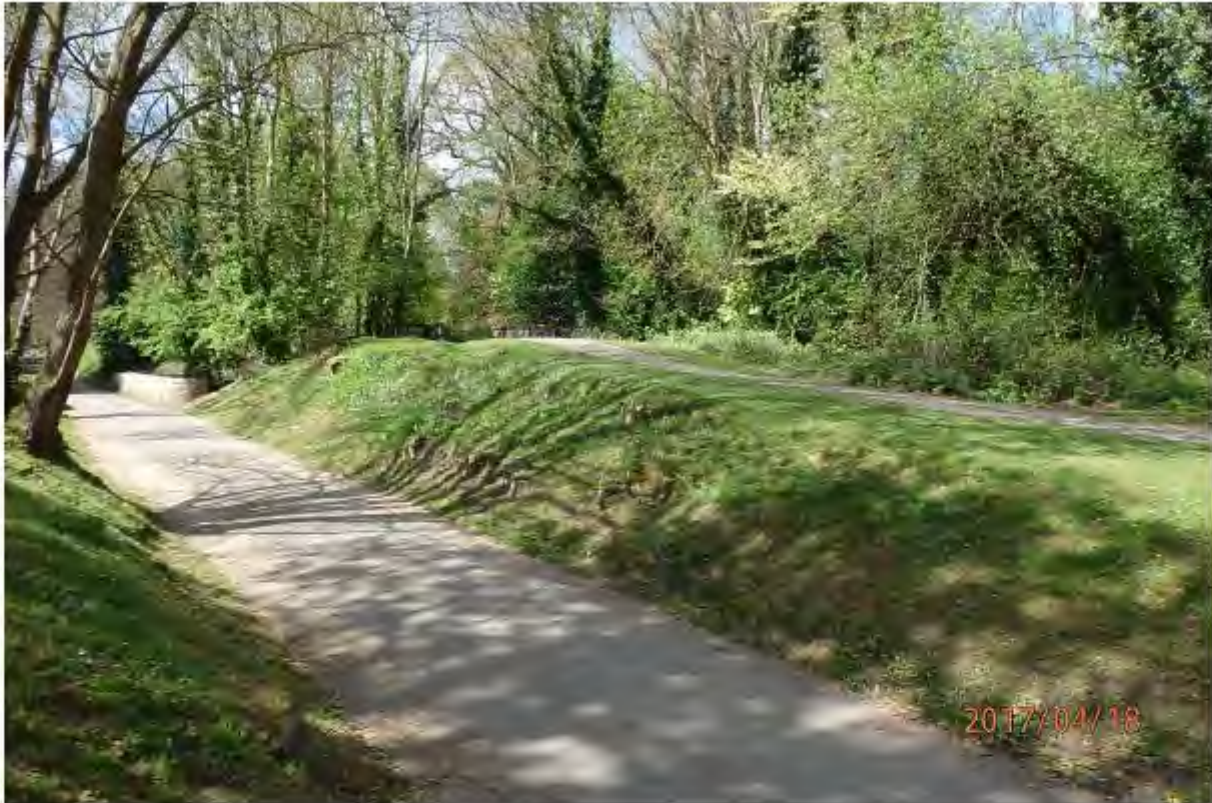
Photograph 12: West ride near existing stream (foreground would be lowered to road level under Option C)

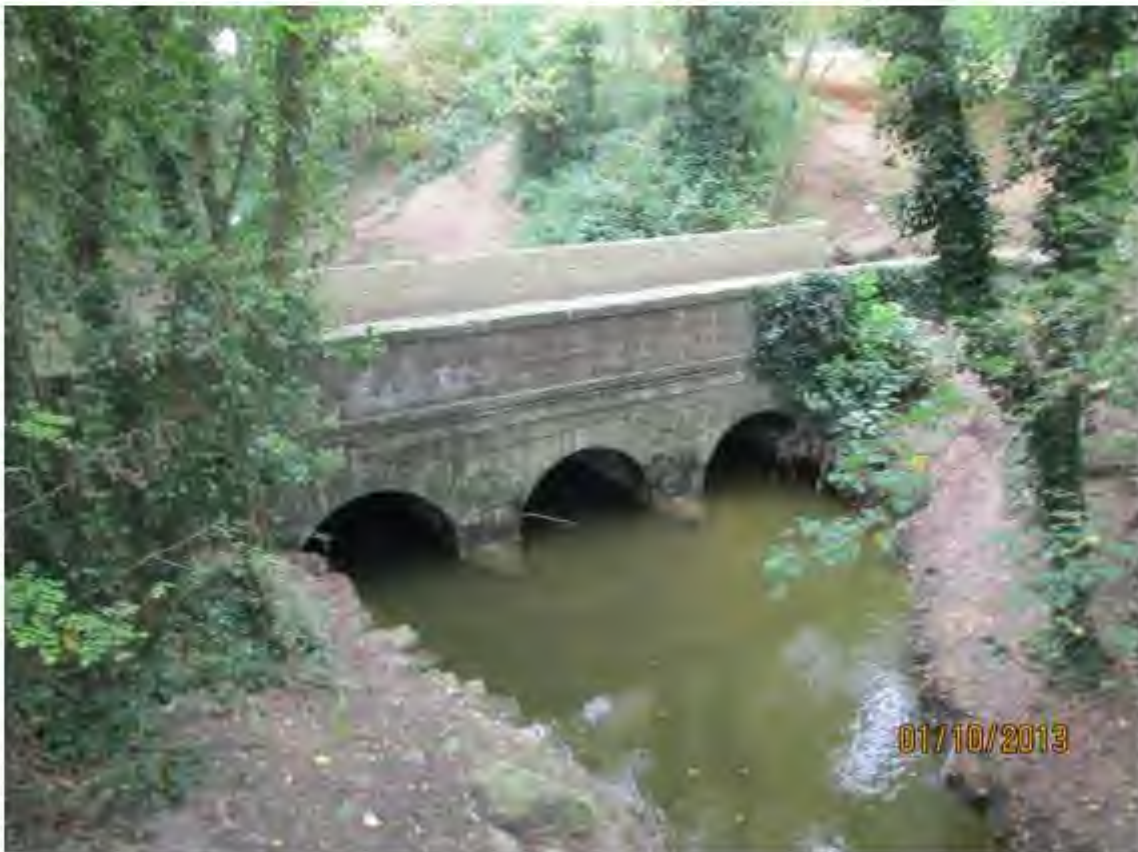
Photograph 13: West Ride bridge over existing spillway channel (control on flows)

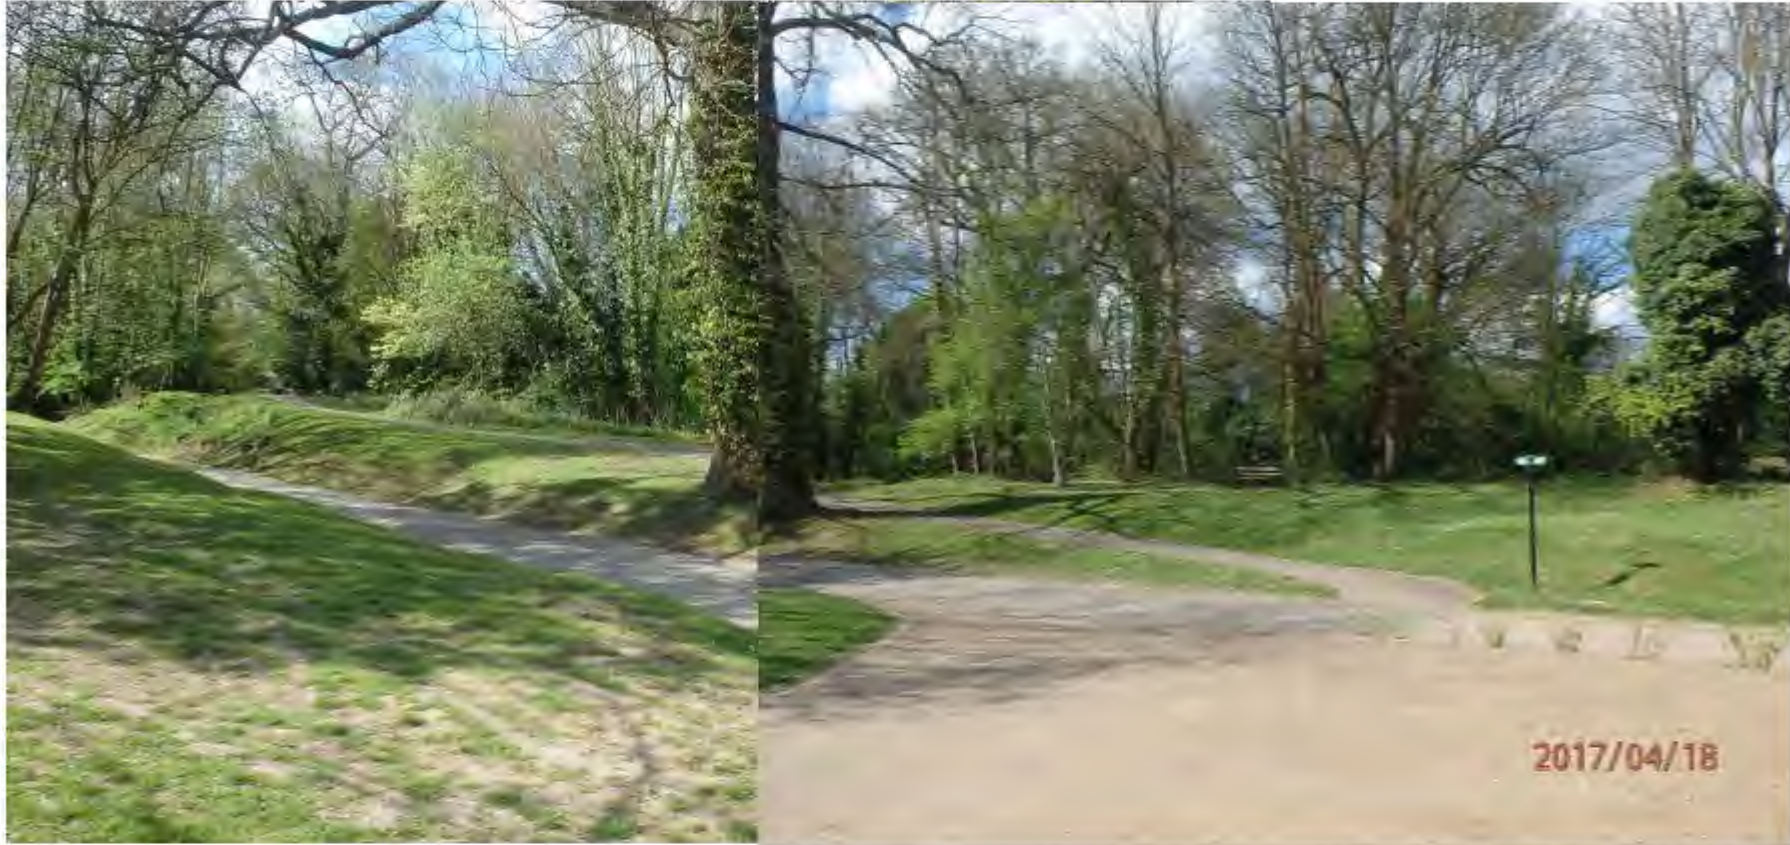
Photograph 14 View from upstream of position of Option C (holly covered stump on right is end is where fence runs up downstream face)

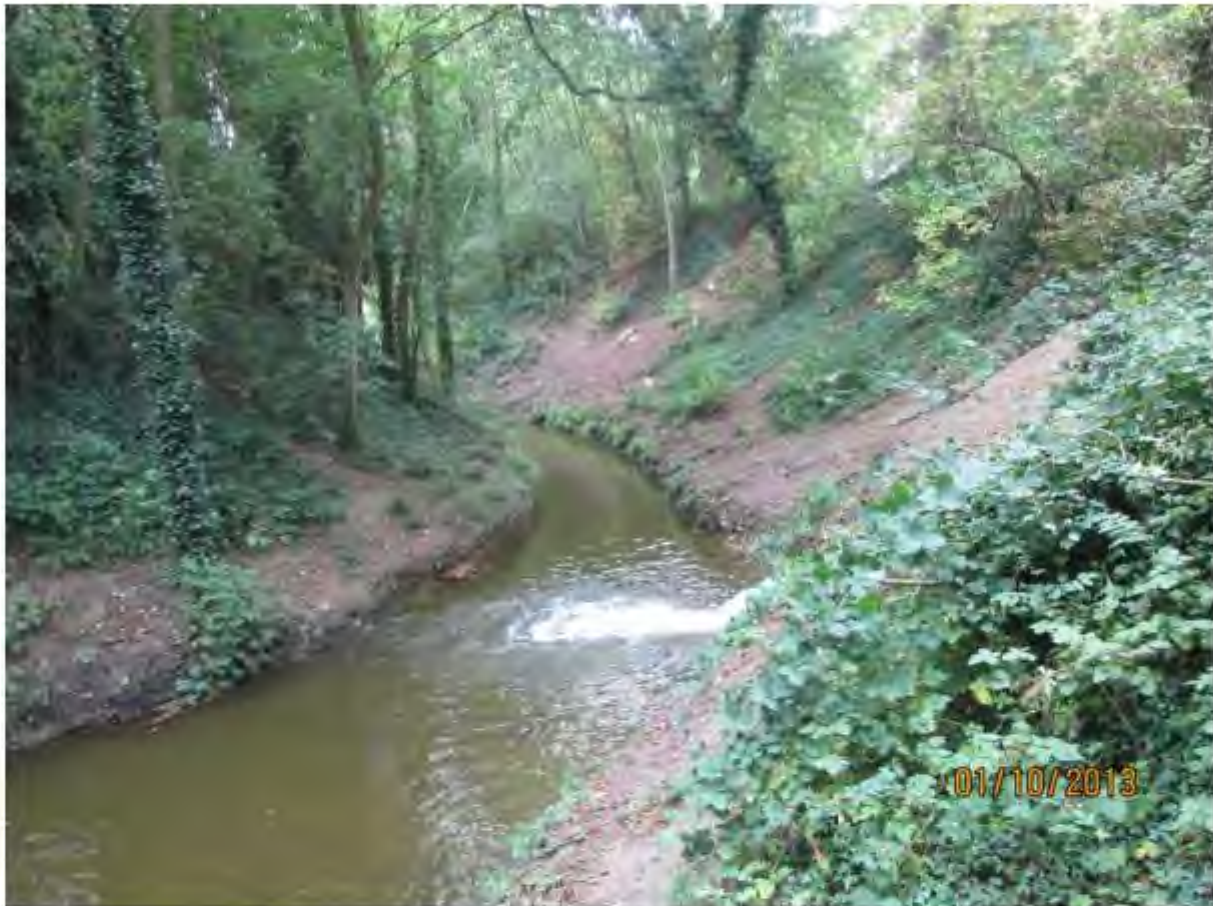
Photograph 15: Spillway channel from downstream end (Option C would mean removal of trees and lowering by several metres)

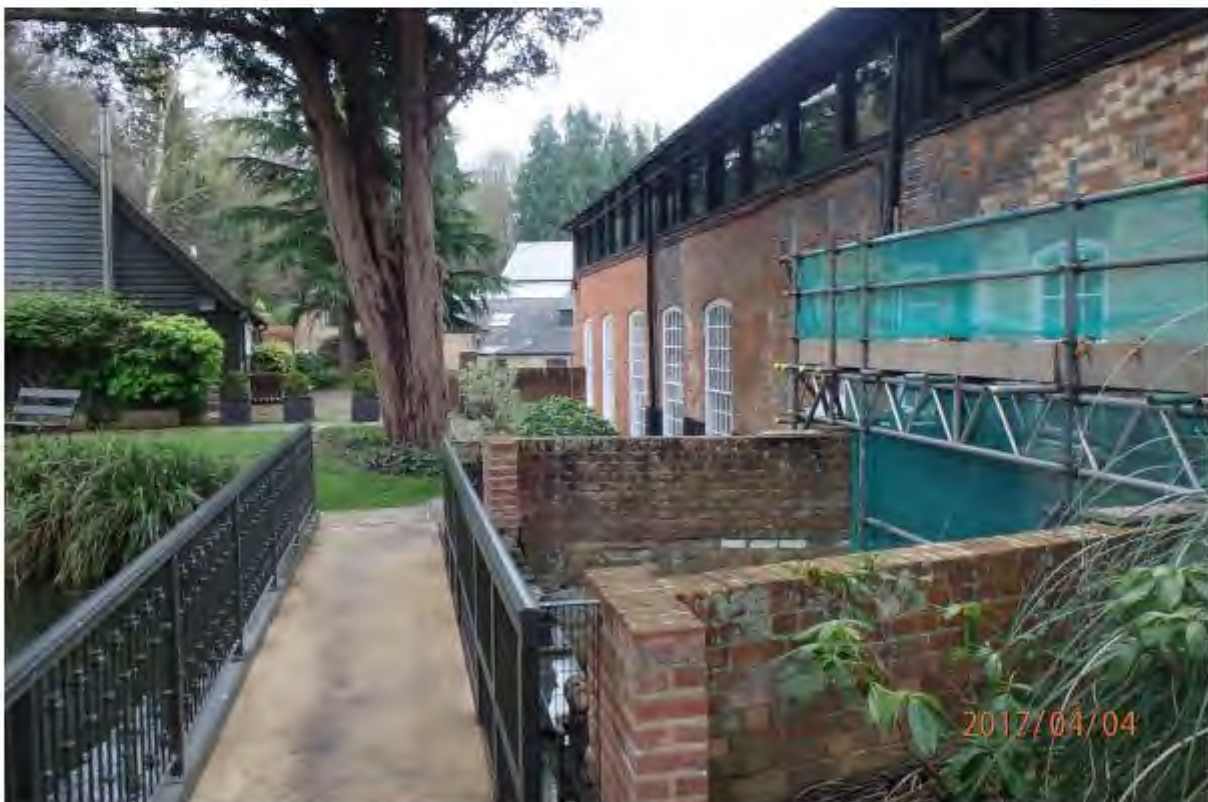
Photograph 21: View indicating floor level of Mill building well below level of Mill race
