Tree Condition Report
on Behalf of
Mr and Mrs Jarvis

Barry Carter BSc M.I.C For

In Relation To:
Trees Located at Land Known as Chickenden Barn, Staplehurst Kent. TN12 0DP

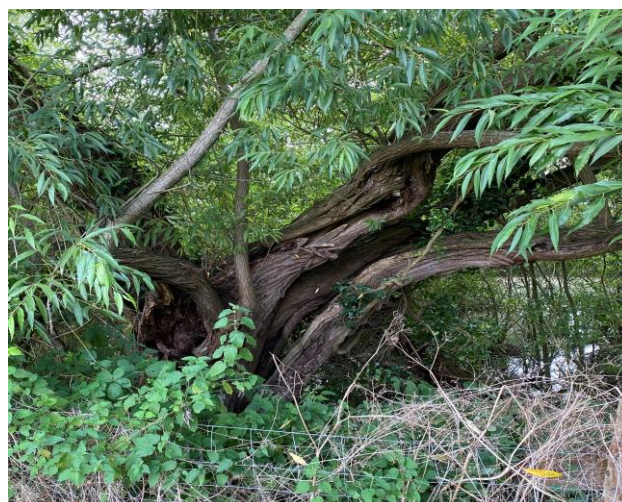
On the western boundary of the pond are several scrubby, poorly formed and, in pats, damages willow trees. Most of the willows are showing signs of instability and structural damage. The below image details a structurally poor tree that has continued to survive for many years.

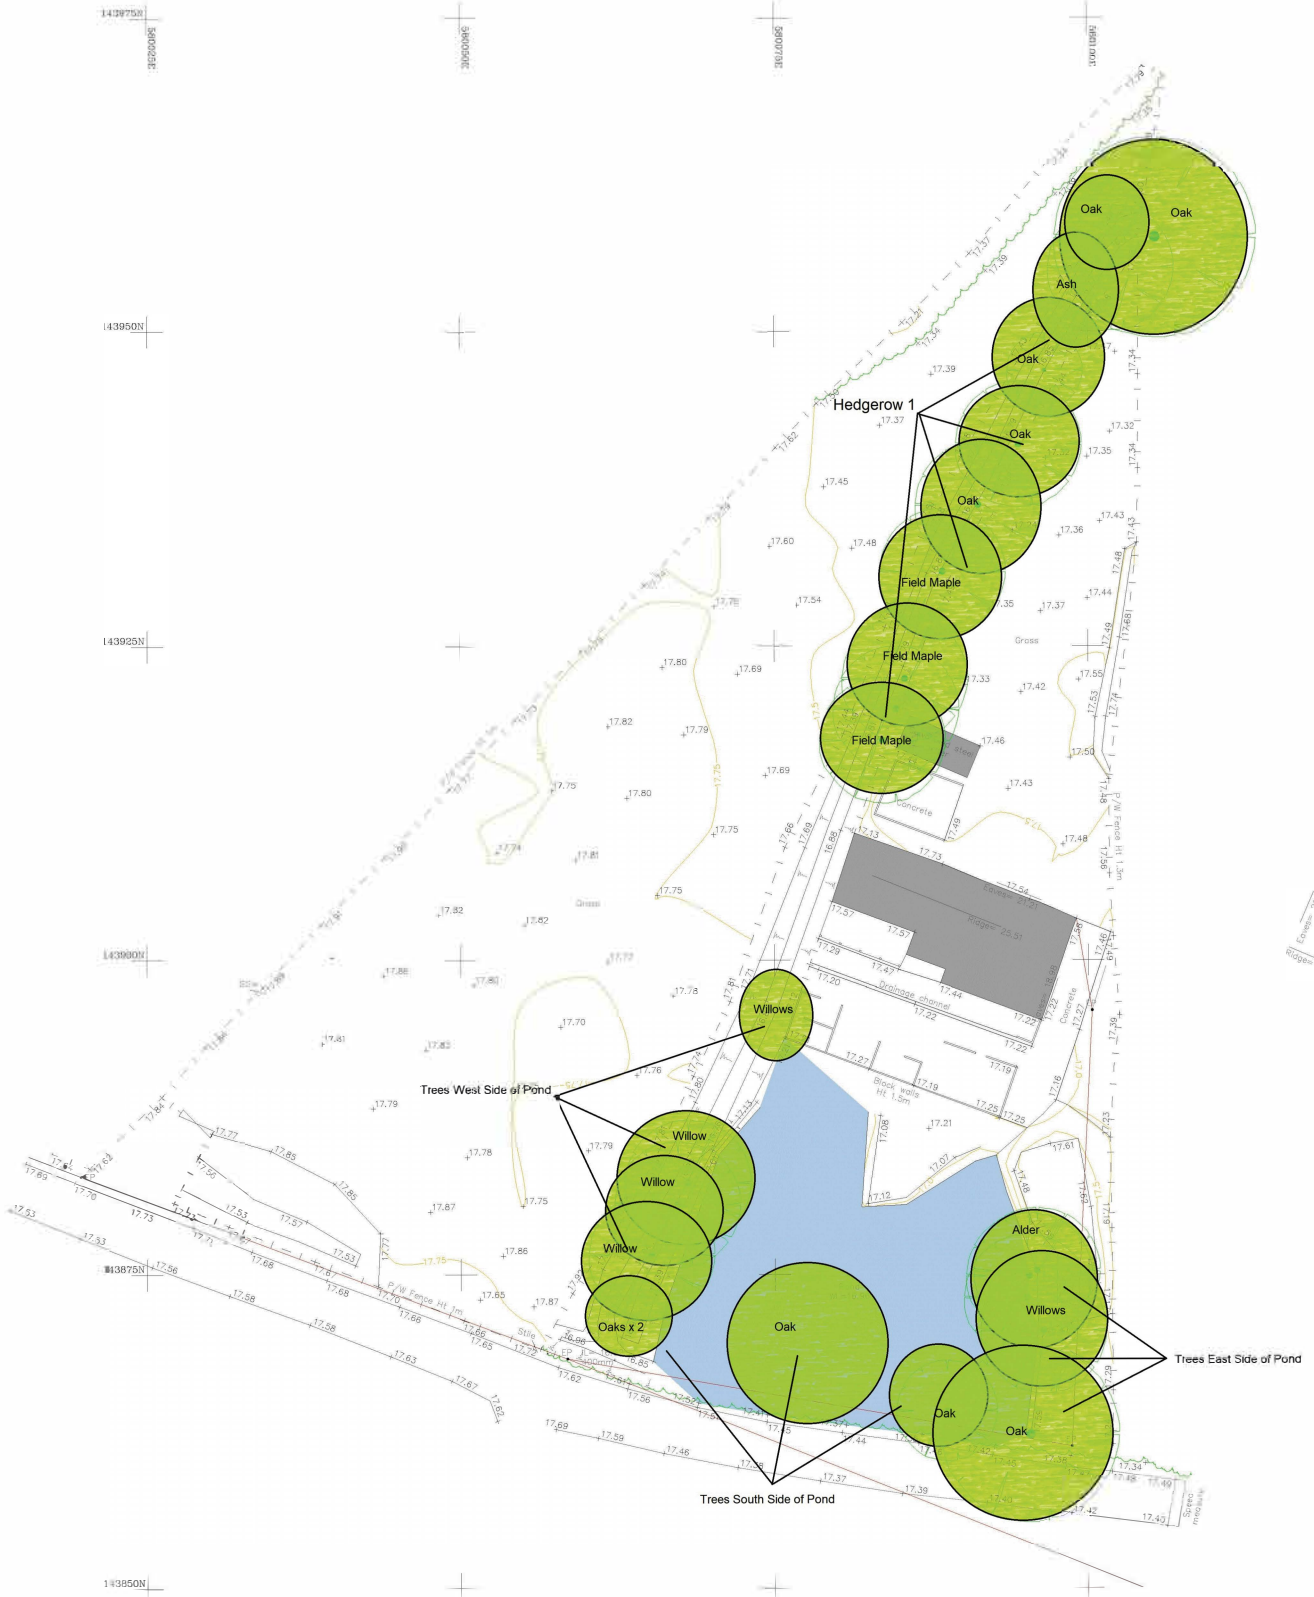
**9 :
Tree Location Plan**

1. Hedgerow 1 : Tress in a continuous line running from south to north along the central line on the west side of the existing barn.
2. East Side of the pond
3. West Side of the pond
4. Southern Side of the pond adjacent Chickenden Lane

Tree Group	Species	Recommended Work
Hedgerow 1	Field Maple, Oak and Ask	Reduce lateral growth and overhang to garden side and paddock side of all trees by 30%. Remove larger deadwood throughout trees.
Trees East Side of Pond	Willow and Alder	Coppice / pollard trees closest to neighbouring property to alleviate risk of damage to structures in case of structural failure
Trees West Side of Pond	Willow	Coppice all leaning and falling trees to rejuvenate. Allow to re-coppice and keep managed every 10 yrs
Pond Trees , southern boundary	Oak and Willow	No work Required
