Goudhurst Road, Marden

Zebra Crossing

Stage 4 Road Safety Audit

March 2014

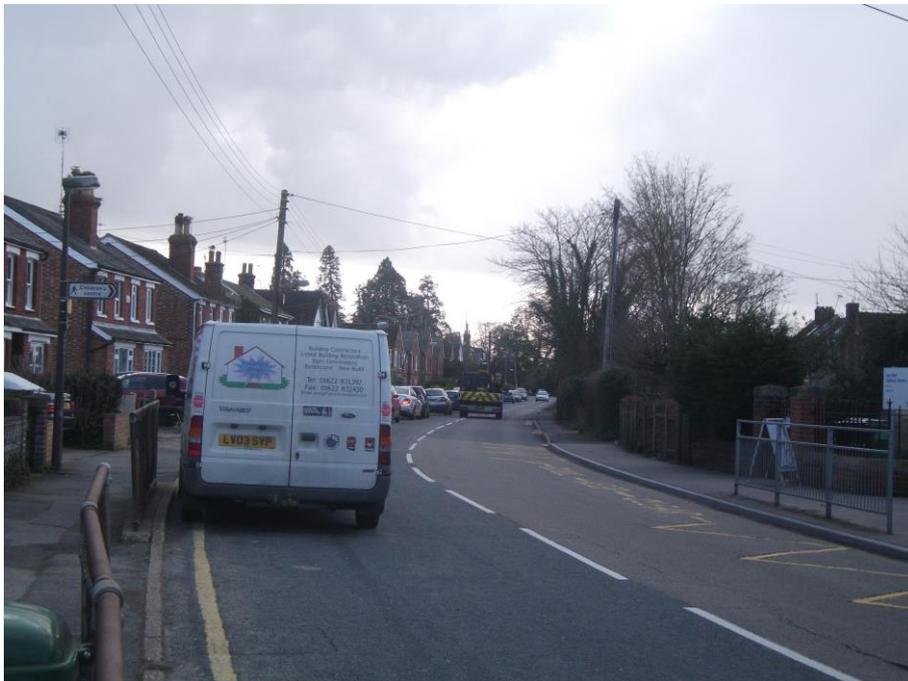
The speed of traffic on the northbound approach to the crossing site was observed to be generally above the posted 30mph speed limit. This is exacerbated further by the presence of parked vehicles on the eastern side of the approach (photo 1) which slows traffic exiting the village but maintains a higher speed for traffic entering and approaching the crossing.

This was observed to result in late braking by drivers when a pedestrian was on the western side of the crossing. There is some evidence of skid marks on the high friction surface on this approach. This may result in drivers failing to brake in time or failing to stop and striking a pedestrian using the crossing.

Photo 1 – Parked vehicles on the eastern side of the road

It is recommended that a permanent interactive sign is installed on the northbound approach displaying the sign to diagram 545 with SLOW message beneath. It is also recommended that dragons' teeth markings are installed to further enhance the existing SLOW marking on the northbound approach.

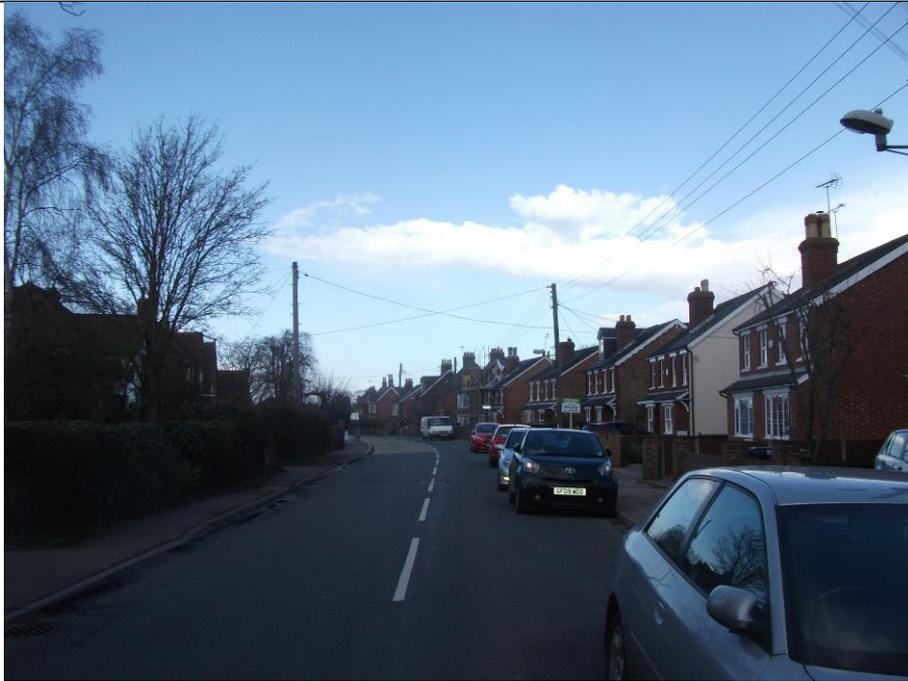
The presence of the zebra crossing is not conspicuous during daylight hours due to the beacons being installed against a busy street scene (photo 2). This may result in late recognition of the facility and late braking on the approach or failure to stop which may lead to a collision with pedestrians using the crossing.

Photo 2 – Busy street scene makes the beacons less conspicuous

It is recommended that backing boards and alternative hoods are installed to increase the conspicuity of the crossing location.

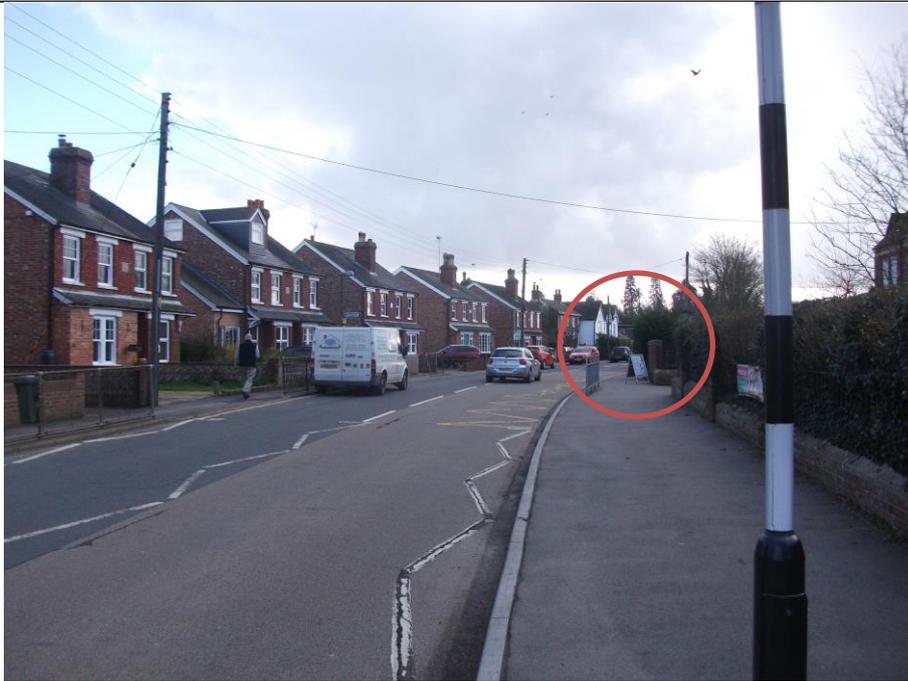
The measured stopping sight distance (SSD) for drivers approaching the crossing northbound towards the western beacon is 43m (Photo 3). The required SSD for a 30mph approach speed is 43m. If traffic was travelling at 37mph the required SSD would be 59m (Manual for Streets 2) which will result in late braking if traffic is travelling at more than the posted 30mph speed limit. Visibility for pedestrian towards northbound traffic is further reduced by the presence of an A fame sign within the visibility splay and the overgrown boundary hedge (Photo 4).

Photo 4 – Visibility looking south from the western side of the crossing

It is recommended that the recommendations in 2.1 and 2.2 are implemented. If the traffic survey recommended in 2.1 reveals traffic at significantly higher speeds than the posted speed limit, more substantial traffic management or calming features will be required.

It is also recommended that the existing zig zag markings are extended on all corners of the crossing to increase the advance warning of the crossing.

It is recommended that the A frame sign is removed and that the hedge is reduced to increase the visibility splay.
