REPORT SUMMARY

CASE REFERENCE: 22/502529/TPOA		
ADDRESS: 'Holtye Cottage', Headcorn Road, Staplehurst TN12 0BU		
PROPOSAL: TPO application to reduce one Oak to 9.0m in height and reduce lateral branch system by 1.0m to 1.5m balancing the crown. Remove re-growth triennially; remove one Oak (fell) to near ground level. Owner to physically remove any regrowth (no chemical treatment due to translocation risk).		
RECOMMENDATION: Permit – subject to CONDITIONS and INFORMATIVES		
SUMMARY OF REASONS FOR RECOMMENDATION: On the evidence submitted, the proposed works are considered necessary arboricultural operations for the mitigation of subsidence.		
REASON FOR REFERRAL TO COMMITTEE: Cllr John Perry has requested the application be taken to committee due to the sensitivity and complexity of the proposal and its reasons		
PARISH: Staplehurst	WARD: Staplehurst	
APPLICANT: Crawford and Company	AGENT: MWA Arboriculture Ltd

MAIN REPORT

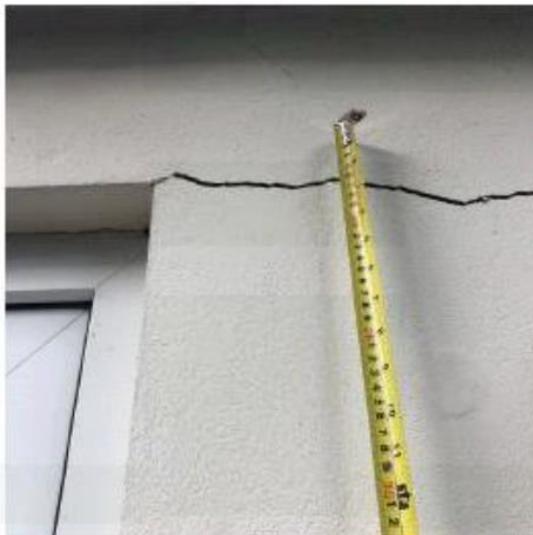
- 10.03 The evidence provided by the applicant indicates that the damage being caused to their property 2 Hurst Close' is attributed to soil desiccation causing a downward rotational movement of the central rear elevation of the property. This movement has resulted in visible open cracks (up to 10mm wide) both inside and outside the property as replicated in the photos below, taken from the submitted technical report by Crawford Ltd.

Crack above rear door.

- 10.04 In structural terms the damage falls into Category 3 of Table 1, Building Research Establishment5 Digest 251, which describes it as "**moderate**".

- 11.01 In light of the evidence submitted with this application the proposed works are considered necessary arboricultural practice to help mitigate subsidence related damage to the property of 2 Hurst Close and are therefore considered acceptable on arboricultural grounds.

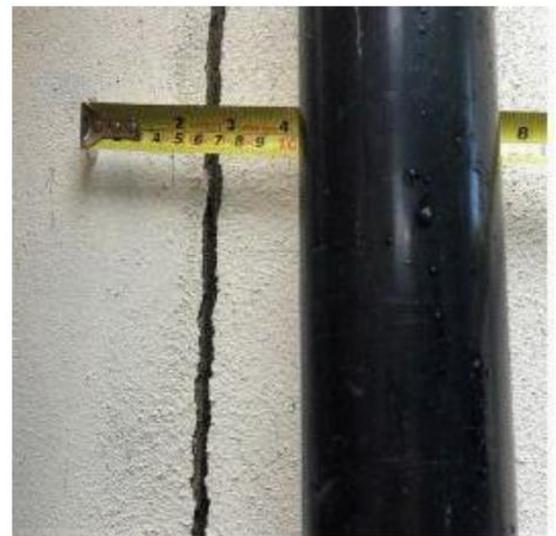
Crack on rear wall.

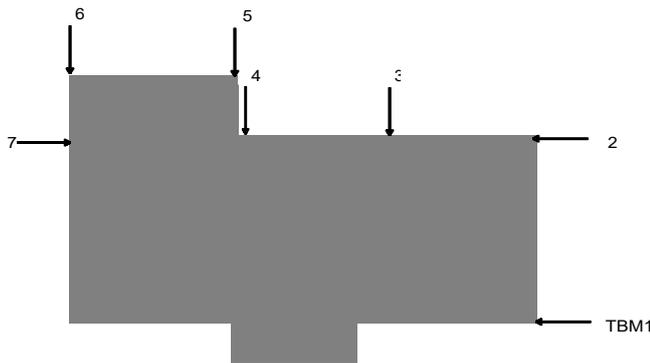
FRONT.

- 20/02/23 Readings taken.
- A common brickcourse could not be followed, subsequently relative data only.
- No further readings are planned

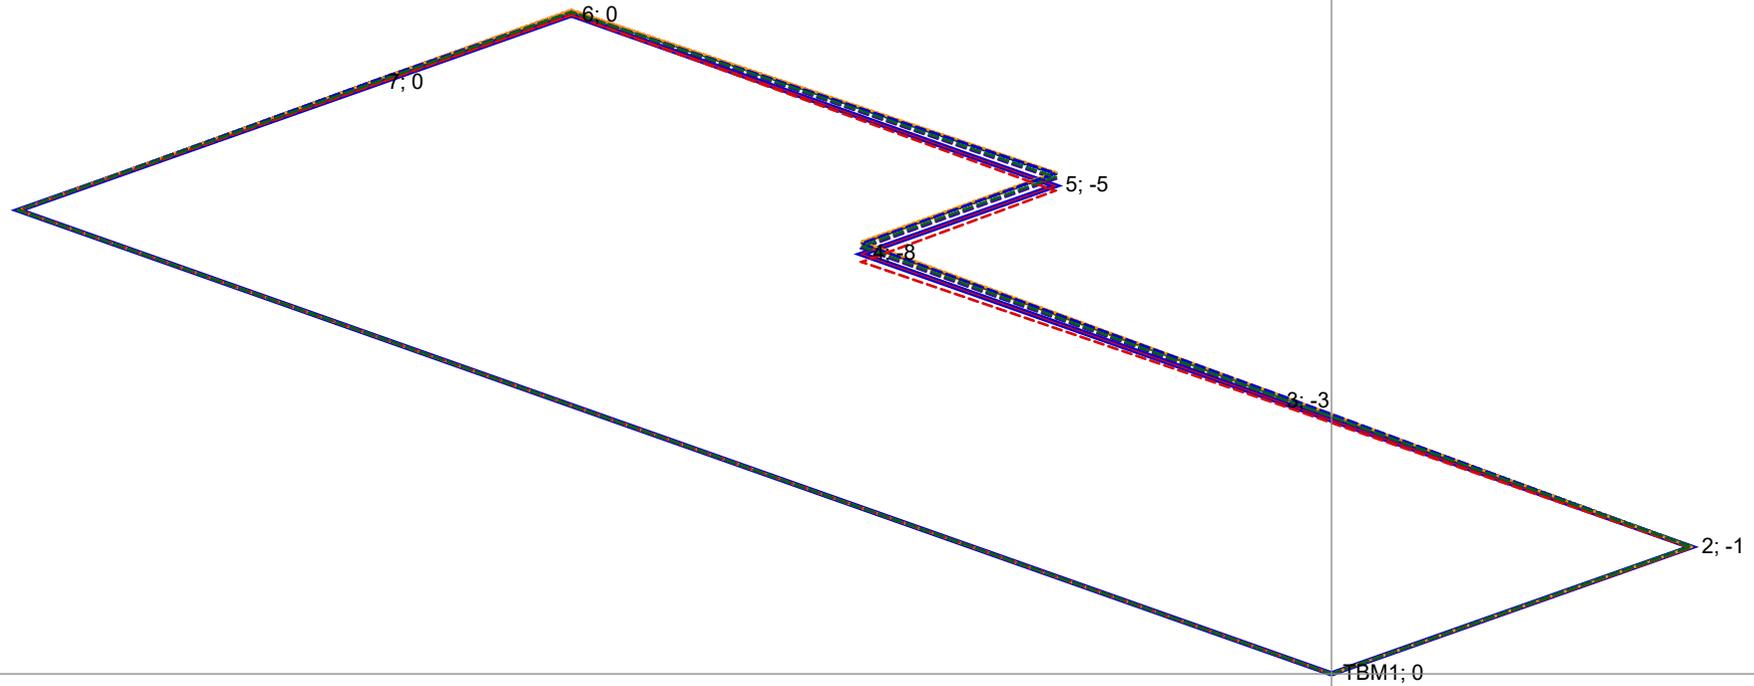
LEVEL MONITORING - RELATIVE MOVEMENT SKETCH

10.07 The property has been monitored at regular intervals since 2020 and the most recent set of crack monitoring and leveling results are attached to this report at Appendix A. These results show the movement of the building to be confined to the central rear elevation of the property in the area that shows the most visible cracking as shown in the photos at section 10.01 above. The results would also indicate a pattern of seasonal movement consistent with the drying and rehydrating of the underlying clay subsoil soil.

Point labels give level difference of last reading from original datum in mm.
