REPORT SUMMARY

CASE REFERENCE: 22/502529/TPOA		
ADDRESS: 'Holtye Cottage', Headcorn Road, Staplehurst TN12 0BU		
PROPOSAL: TPO application to reduce one Oak (T2) to 9.0m in height and reduce lateral branch system by 1.0m to 1.5m balancing the crown. Remove re-growth triennially; remove one Oak (T3) (fell) to near ground level. Owner to physically remove any regrowth (no chemical treatment due to translocation risk).		
RECOMMENDATION: Permit – subject to CONDITIONS and INFORMATIVES		
SUMMARY OF REASONS FOR RECOMMENDATION: On the evidence submitted, the proposed works are considered necessary arboricultural operations for the mitigation of subsidence.		
REASON FOR REFERRAL TO COMMITTEE: Cllr John Perry has requested the application be taken to committee due to the sensitivity and complexity of the proposal and its reasons. The application was subsequently reported to the Planning Committee on 23 rd March, who resolved that it should be deferred so officers could evaluate the CAVAT monetary value of the trees involved in order for members to see comparative costs against the potential compensatory values if the application was to be refused.

MAIN REPORT

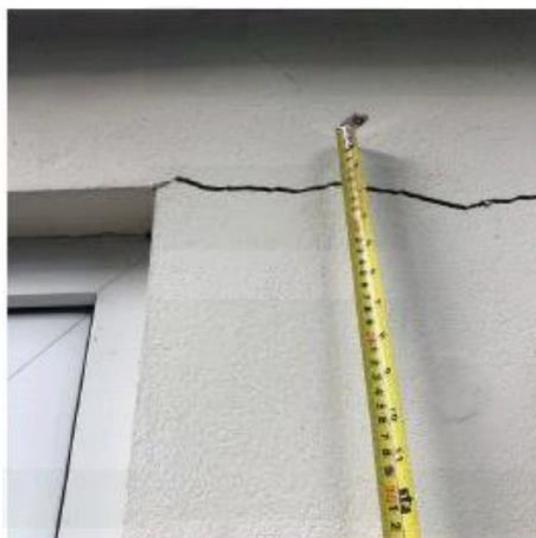
- 10.03 The evidence provided by the applicant indicates that the damage being caused to their property '2 Hurst Close' is attributed to soil desiccation causing a downward rotational movement of the central rear elevation of the property. This movement has resulted in visible open cracks (up to 10mm wide) both inside and outside the property as replicated in the photos below, taken from the submitted technical report by Crawford Ltd.

Crack above rear door.

- 10.04 In structural terms the damage falls into Category 3 of Table 1, Building Research Establishment Digest 251, which describes it as "**moderate**".

- 11.01 In light of the evidence submitted with this application the proposed works are considered necessary arboricultural practice to help mitigate subsidence related damage to the property of 2 Hurst Close and taking all other matters into consideration are therefore considered acceptable on arboricultural grounds.

GRANT CONSENT– Subject to the following CONDITIONS / REASONS and INFORMATIVES.

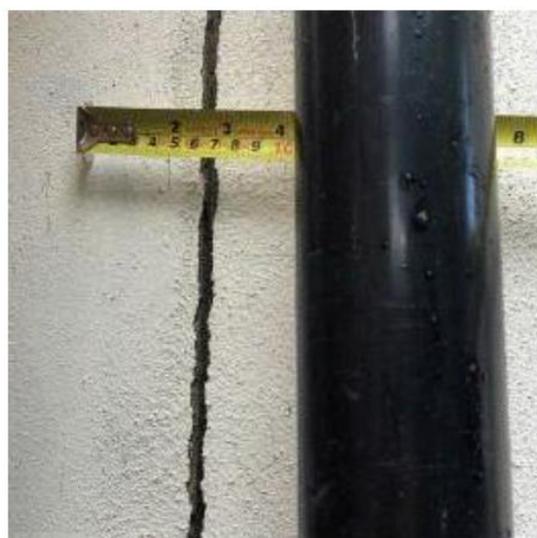
Crack on rear wall.

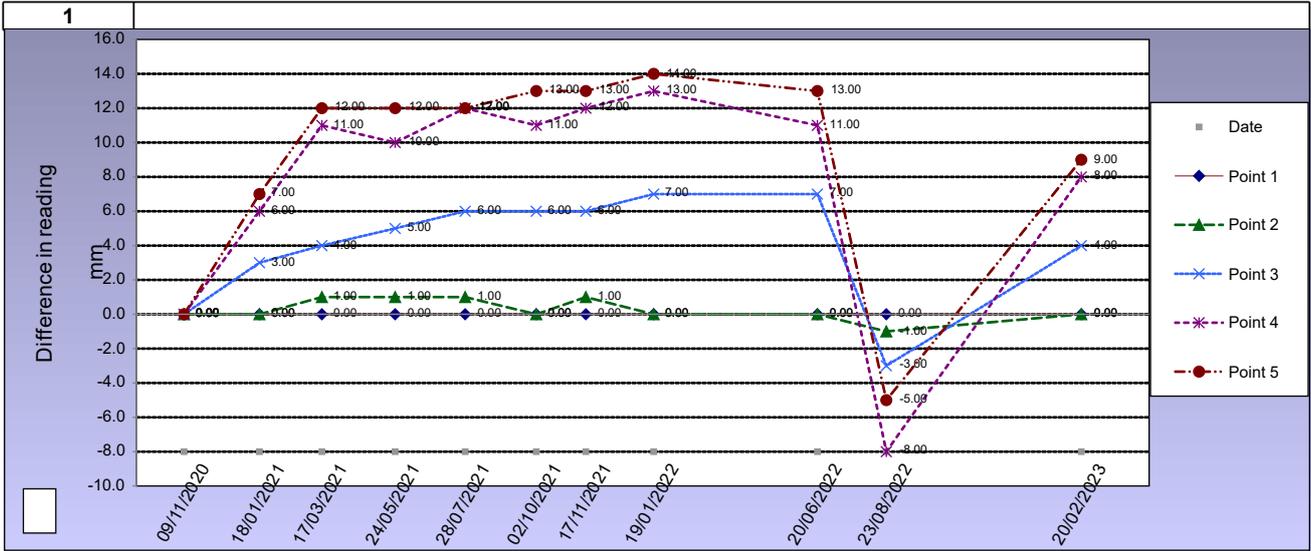
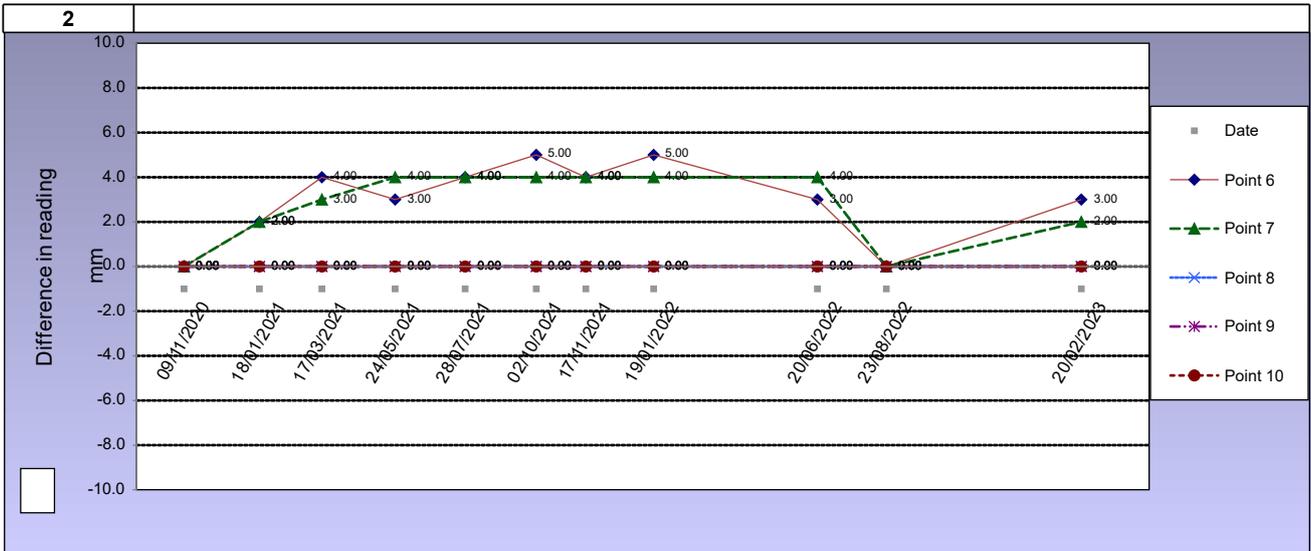
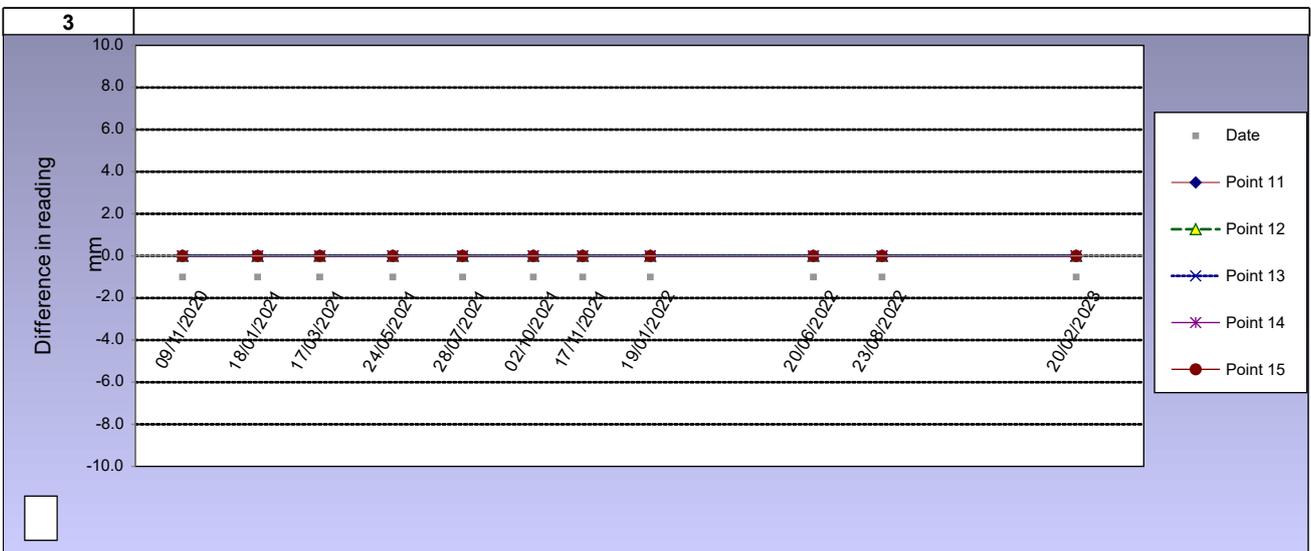
LEVEL MONITORING - RELATIVE SURVEY READINGS

Chart Scale 1:1000
