MAIDSTONE BOROUGH COUNCIL

Mote Park Lake

**Assessment of whether the risk of failure of the dam
during flood events is
“As low as reasonably practicable” (ALARP)**

April 2017

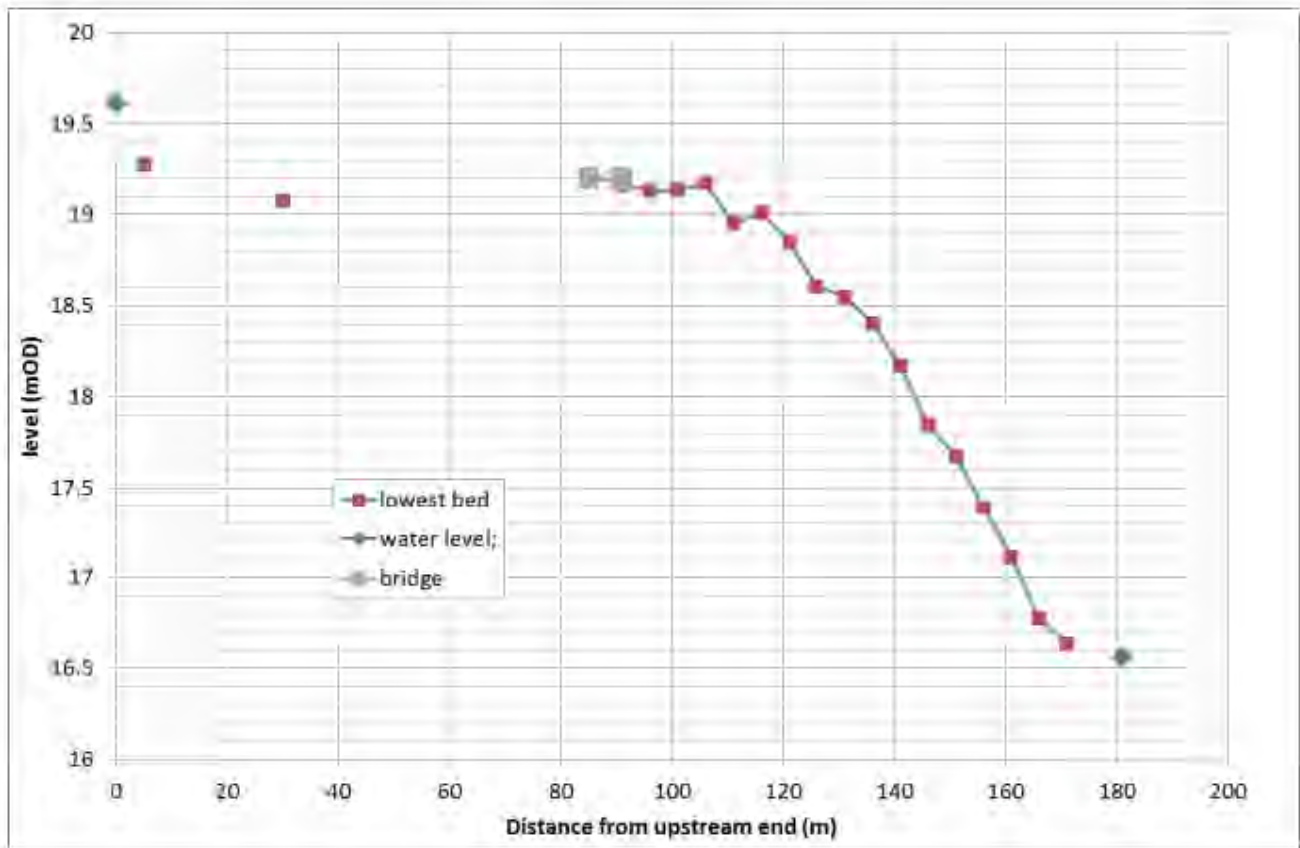
Figure 3.5: Long section down spillway channel

The spillway comprises two culverts discharging into a modest earth channel, with the control at high flows becoming the three culverts under the Northwest Drive, with dimensions modelled as below. The existing spillway capacity is shown on Figure 3.5, whilst a long section along the dam crest (looking downstream) is shown in Figure 3.3.

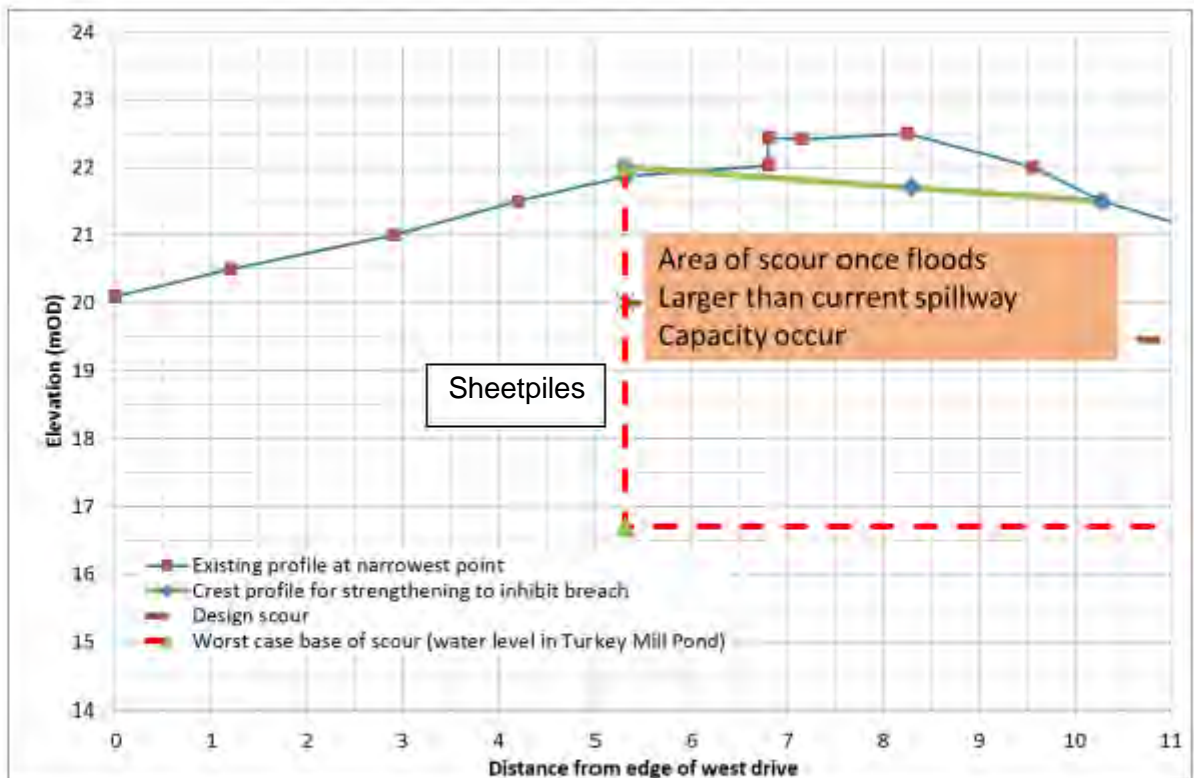
Figure 6.4: Cross section on strengthened crest (Option B)

One option that would minimise the works on the downstream face, which is not owned by the undertaker, would be to strengthen the crest to increase resilience to breach. This would not change the annual chance of damage to the downstream face, and it would be prudent to have contingency plans in place for repairs, which should include constructing an auxiliary spillway over the damaged section.

It is estimated that this would provide an annual probability of failure equivalent to use of a grass reinforced (open mat) auxiliary spillway. Clearly the annual chance of damage (scour to the downstream face) would remain at 1 in 100 per year.

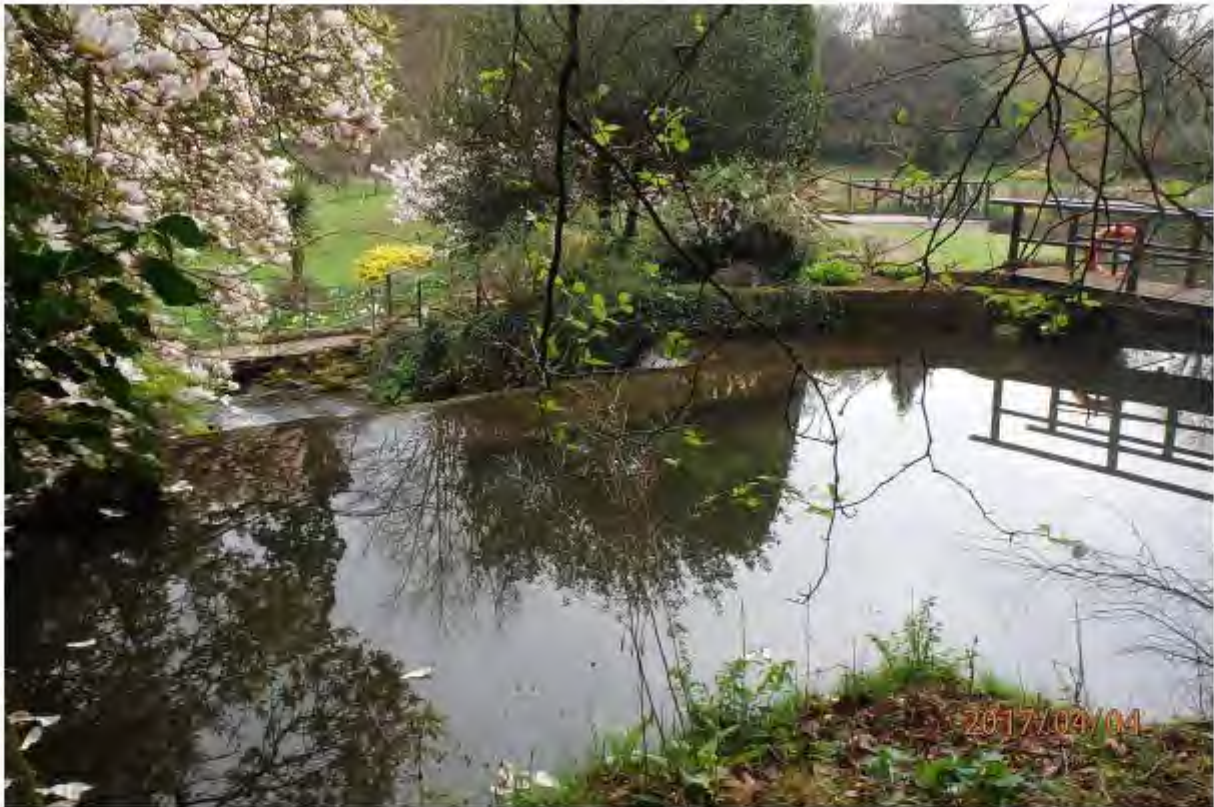
Photograph 18: Spillway from Turkey Mill Pond

Location	Weir		Photos	Comments	Indicative dam critical flow (onset of damage)
	Crest length	Freeboard			
Turkey Mill Lake	6m (L shaped)	0.5 (viewing platform 0.48m above WL)	18	water 6cm deep on 04 April	
Gates on River Len	3 gates, 1.54, 1.48 and 1.54 opening	Crest of middle gate 18cm below "fixed" side gates	19	2cm water depth on sides 150mm freeboard to underside of bridge	
Culvert under mill	3.5 wide	Height not available (obscured by scaffolding)	20
