To: Maidstone Joint Transportation Board
By: KCC Highways and Transportation
Date: 30th July 2024
Subject: Petition – Replacement of Camera in Loose Road, Maidstone
Classification: Information Only

Summary: This information report provides an update regarding the 125 signature petition received requesting replacement of (Safety) camera in Loose Road, Maidstone

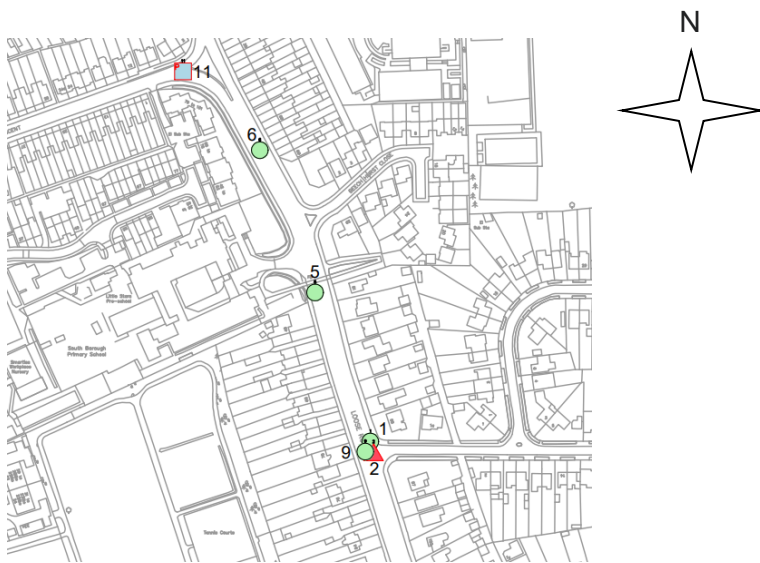
Personal injury crash data

Crash Number	Date	Direction of travel & Location	Detail of crash
11	22/04/2023	North west.. Sheal's Crescent	Rear end shunt. Speeds not contributory
6	08/09/2021	South. Loose Road	Goods vehicle veered into opposite carriageway. Speeds not contributory
5	28/07/2021	South. Loose Road	Motorcycle overtake stationery traffic, clipped stopped car. Speeds not contributory
1	20/08/2019	North. Loose Road	HGV collided with car. Speeds not contributory
9	25/08/2022	North. Loose Road jw Heather Drive	Motorcycle right turn from Heather Drive and struck car on Loose Road. Speeds not contributory
2	29/08/2019	South. Loose Road	HGV struck pedestrian. Speeds not contributory
