## COBTREE MANOR ESTATE CHARITY COMMITTEE MEETING

**Kent Life Play Barn Timber Treatment Work**

# Kent Life Play Barn Timber Treatment Work

**RE: PLAY BARN, KENT LIFE, SANDLING, LOCK LANE, MAIDSTONE, ME14 3AU**

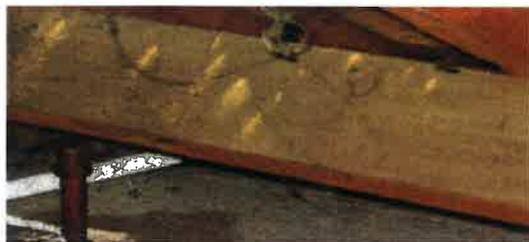
There are several species of wood boring beetle prevalent in structural timbers of properties in the U.K. and the method of eradication varies little from species to species, although any necessary variation from our specification will be noted in your report.

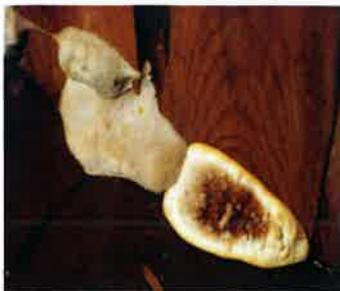
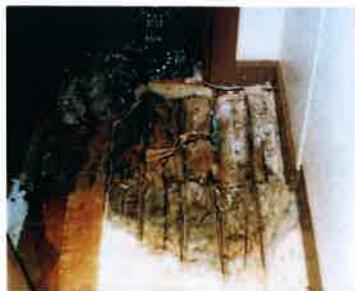
#### DRY ROT (*Serpula lacrymans*)

This like every other fungus requires the presence of moisture in timber, in its initial stages. Once established, however, it has the unique ability to pass unseen from floor to floor, behind plaster finishes and panelling and to affect previously dry timber. Its fungal strands can penetrate brickwork and pass over inert substances such as metal or plastics and colonise other timber in the vicinity.
