**RE: PLAY BARN, KENT LIFE, SANDLING, LOCK LANE,  
MAIDSTONE, ME14 3AV**

## QUOTATION

Standard specification for the treatment of wood boring beetles and fungal decay

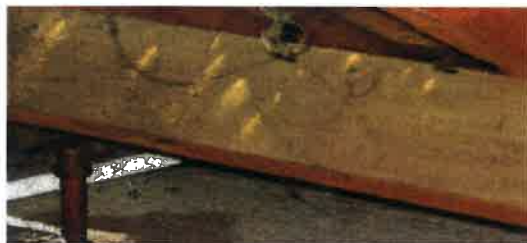
There are several species of wood boring beetle prevalent in structural timbers of properties in the U.K. and the method of eradication varies little from species to species, although any necessary variation from our specification will be noted in your report.

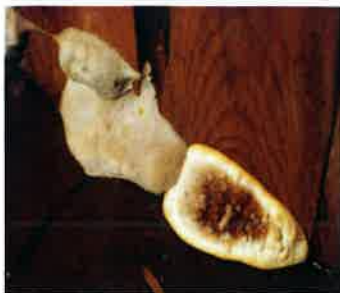
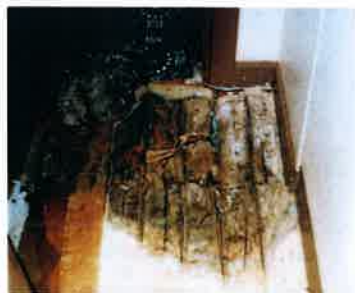
This like every other fungus requires the presence of moisture in timber, in its initial stages. Once established, however, it has the unique ability to pass unseen from floor to floor, behind plaster finishes and panelling and to affect previously dry timber. Its fungal strands can penetrate brickwork and pass over inert substances such as metal or plastics and colonise other timber in the vicinity.
